Environmental Assessment and Soil Removal

Metal Hardware Manufacturing Facility, Mauldin, South Carolina

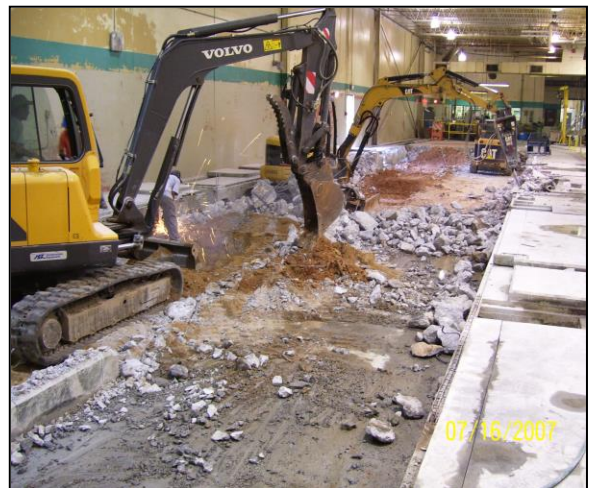
After coring holes in the concrete floor, underlying soil samples were collected and analyzed for metals, cyanide, and VOCs. Elevated concentrations of nickel were present in an area where nickel plating had occurred. Nickel concentrations were initially compared to the US EPA Region 9 Risk Based Concentration/Soil Screening Level of 130 mg/kg. However, a review of the calculations used to determine the SSL revealed an inconsistency. The calculations used the former Maximum Contaminant Level (MCL) for nickel of 0.100 mg/L as the applicable groundwater target. Since this MCL was remanded by EPA in 1995, the tap water PRG listed in the Region 9 RBC table (0.730 mg/L) was used as a more appropriate groundwater target, resulting in a revised SSL for nickel of 952 mg/kg.

Soil removal began in July 2007 in an area approximately 20 feet by 15 feet. Based on TCLP results, the removed concrete was recycled. The vertical extent of the soil removal was guided by additional soil sampling, including samples collected using direct push equipment. Rapid turnaround from the Rogers & Callcott laboratory resulted in no delays during soil removal. Based on the direct push sample results, soil was removed down to the water table within the target area.

The final depth of the excavation was approximately 15 feet. Approximately 315 tons of soil were removed and disposed of at a local subtitle D landfill. The excavation was backfilled with washed no. 57 stone and then capped with 1 foot of crusher run.
