Assessment and Remediation

Electrical Component Manufacturing Facility, Oconee County, South Carolina

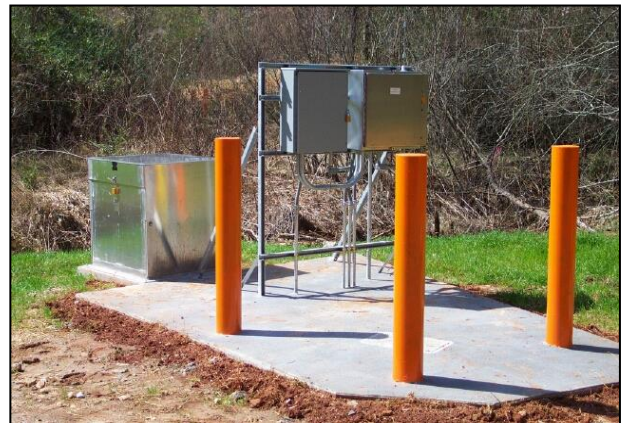
The resulting system is effective in achieving its remedial goals through the use of state of the art data recording and communication technologies to function in sync with changing aquifer conditions as they are significantly affected by precipitation and surface water flow.

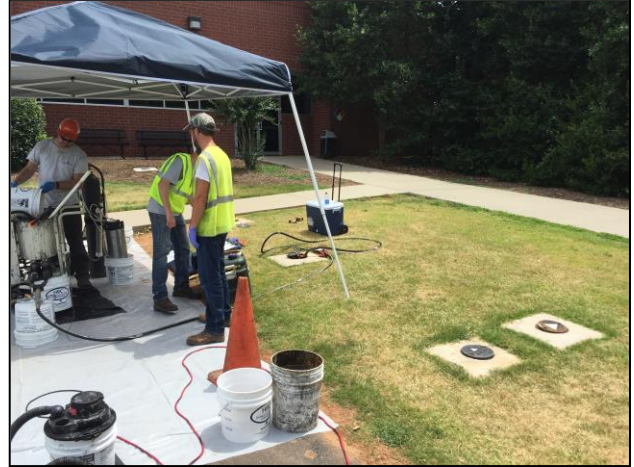
Enhanced In-Situ Bioremediation: Following successful pilot studies for bioremediation in both bedrock and saprolite, four enhanced in-situ bioremediation barriers have been installed at the site to decrease the remediation timeframe—two in the source area, one mid-plume, and one near a property boundary. Combined, the barriers span approximately 600 feet in length and consist of 44 bedrock injection wells and 36 saprolite injection wells. Cultures of *dehalococoides* were injected to augment the microbial community, and a mixture of HRC Primer, HRC X, HRC, and/or 3DMe were injected into the subsurface to stimulate microbial activity. Reducing conditions were established quickly, and contaminant concentrations have decreased substantially.

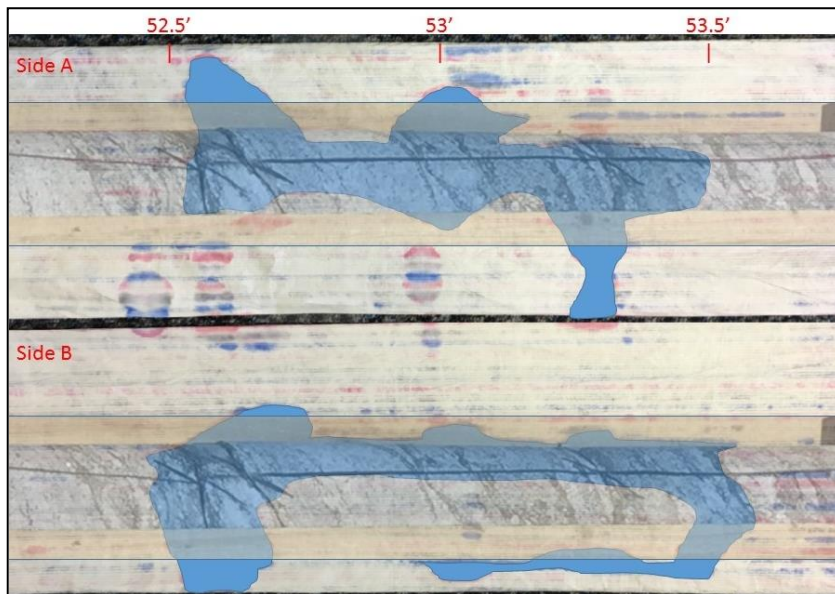
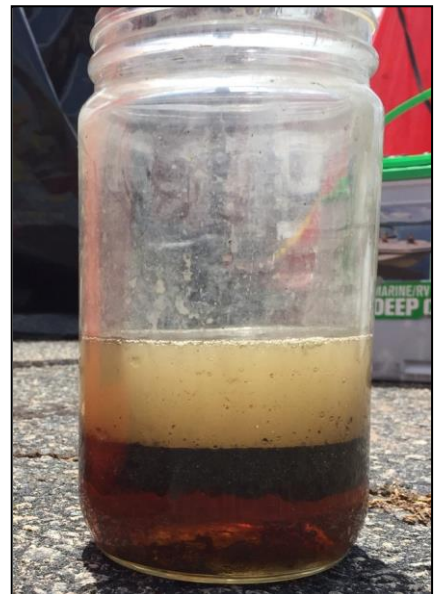
DNAPL Recovery: Free-phase TCE (DNAPL) was discovered while drilling a bedrock injection well in the source area in 2016. We took immediate action to pull all recoverable DNAPL from the well using a bottom-intake pump. Surrounding wells were also assessed for the presence of DNAPL, and injections were delayed until no additional free-phase TCE was flowing to the wells. Approximately 3 months after injection, DNAPL was identified in a performance monitoring well, approximately 10 feet downgradient of the effected injection well. We used downhole video and a FLUTE liner to identify the DNAPL-bearing fractures and used a packer to isolate said fractures from the rest of the well. Using a bottom-intake pump, we removed more than 10 liters of free-phase TCE from bedrock at the site. No additional DNAPL has been observed since late 2017, and contaminant concentrations have been declining rapidly.
